## PROPERTY INSPECTION REPORT FOR 277 Highland View Dr

Joel Rossmann AL # HI-4687 Bama Home Inspections IIc Inspection Address: 277 Highland View Dr Inspection Prepared For: John Smith Date of Inspection: 3/10/2025 Home Age: 4 Home Size: 1730 Weather: 40° Mostley cloudy

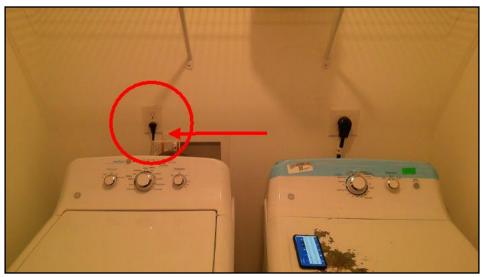
• GFCI outlets should be used in laundry room.

• The laundry receptacle should be GFCI protected type.

Laudry room should have a GFCI outlet.

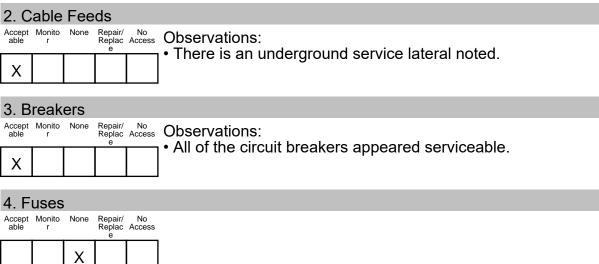
- Observations:
  - No major system safety or function concerns noted at time of inspection at main panel box.
  - Main cutoff on rightside exterior of home.
  - Electrical panel should not have anything in front of it.

Items are not to be placed in front of Electrical panel.

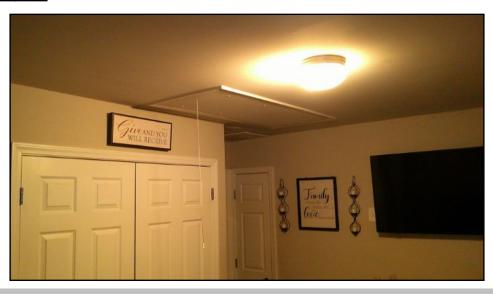
1	1. A	cces	s			
	Accept Monito able r		None			Observations: • Pull Down Ladder located in:
	Х					<ul> <li>Attic light located just inside access.</li> </ul>
